Werrington Brook Improvement Project

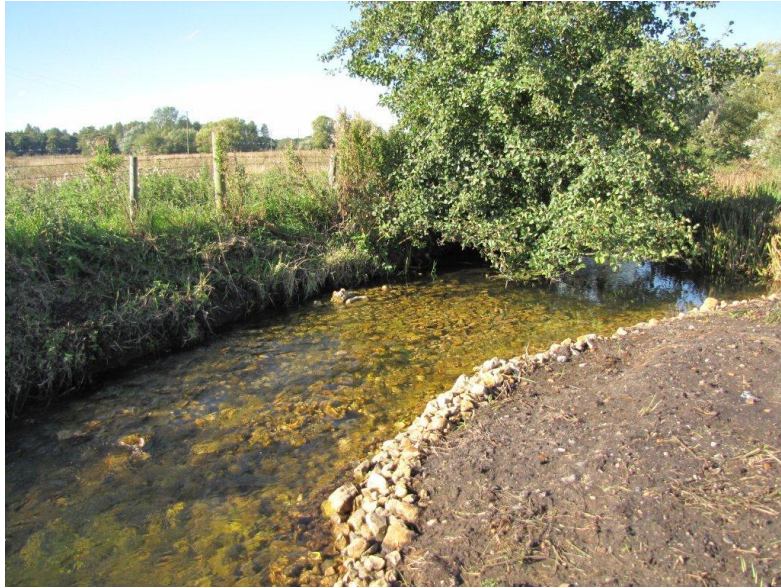
Gravel edged berm immediately after construction

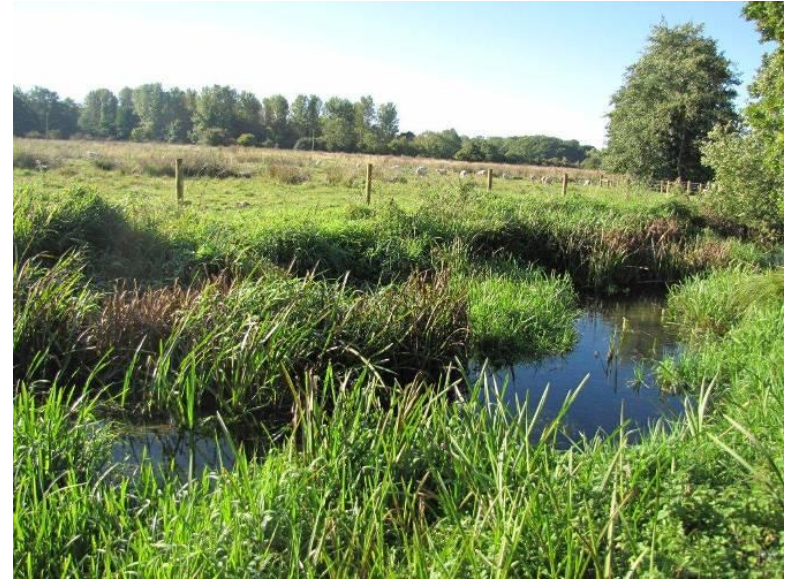
Filled berm naturally vegetated.

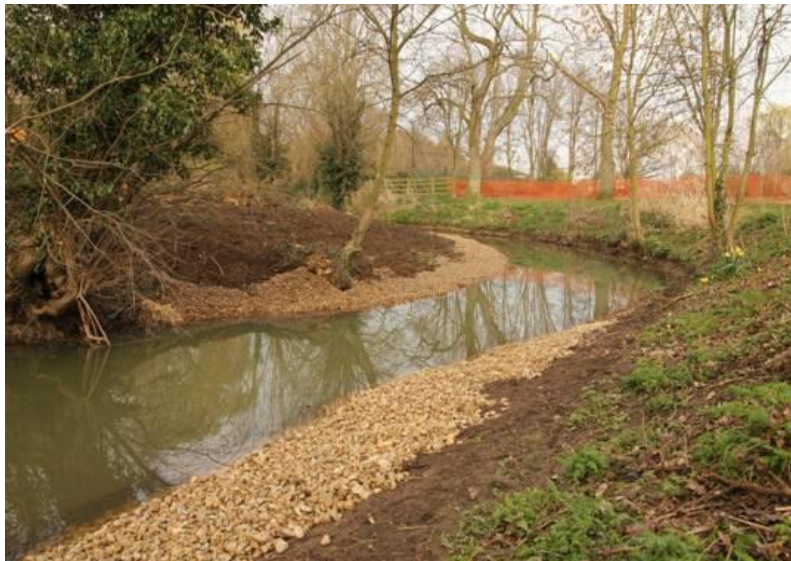
Gravelled berms immediately after construction

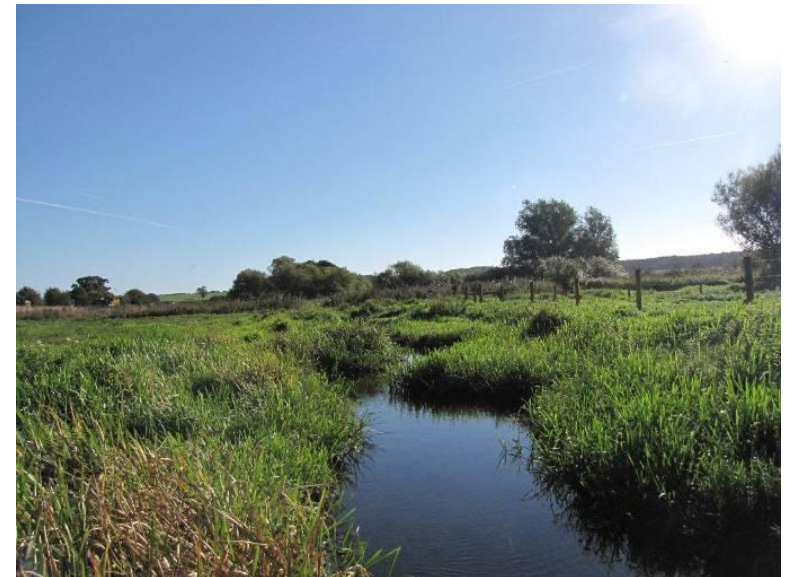
Naturally vegetated filled berms creating meander pattern
